Overheated and melted intracranial pressure transducer as cause of thermal brain injury during magnetic resonance imaging

Case report

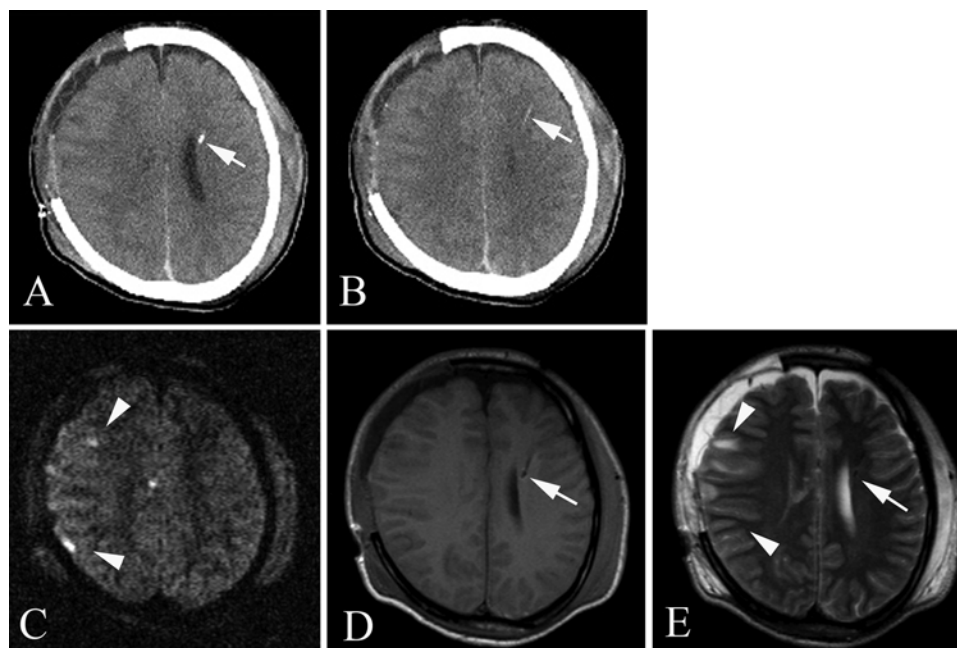
Postoperative Course and Imaging Findings. A CT scan of the patient’s head on hospital Day 5 demonstrated improvement of brain swelling and showed that the tip of the ICP transducer was located in the parenchyma of the left frontal lobe near the frontal angle of the left lateral ventricle (Fig. 1A and B).

When therapeutic hypothermia was discontinued on Day 6, MRI was performed to evaluate the presence of intracranial lesions, including diffuse axonal injury, and any cervical spinal cord injury. The scans revealed contusions of the right temporoparietal lobe only, and no diffuse axonal injury or cervical spinal cord injury (Fig. 1C–E). No contusions were demonstrated in the left cerebral hemisphere.

FIG. 1. **A and B:** Axial CT images obtained on Day 5 after right temporal lobectomy and decompressive craniectomy demonstrating improvement of brain swelling. The ICP transducer tip (*white arrows*) is located in the left frontal lobe parenchyma near the frontal angle of the left lateral ventricle. **C–E:** Axial MR images obtained on Day 6, including diffusion-weighted (C), T1-weighted (D), and T2-weighted (E) sequences. The diffusion-weighted and T2-weighted images demonstrate contusions of the right temporoparietal lobe (*white arrowheads*) but no diffuse axonal injury. No contusions are demonstrated in the left cerebral hemisphere. The T1-weighted and T2-weighted images also demonstrate that the ICP transducer tip (*white arrows*) is located in the left frontal lobe parenchyma near the frontal angle of the left lateral ventricle.

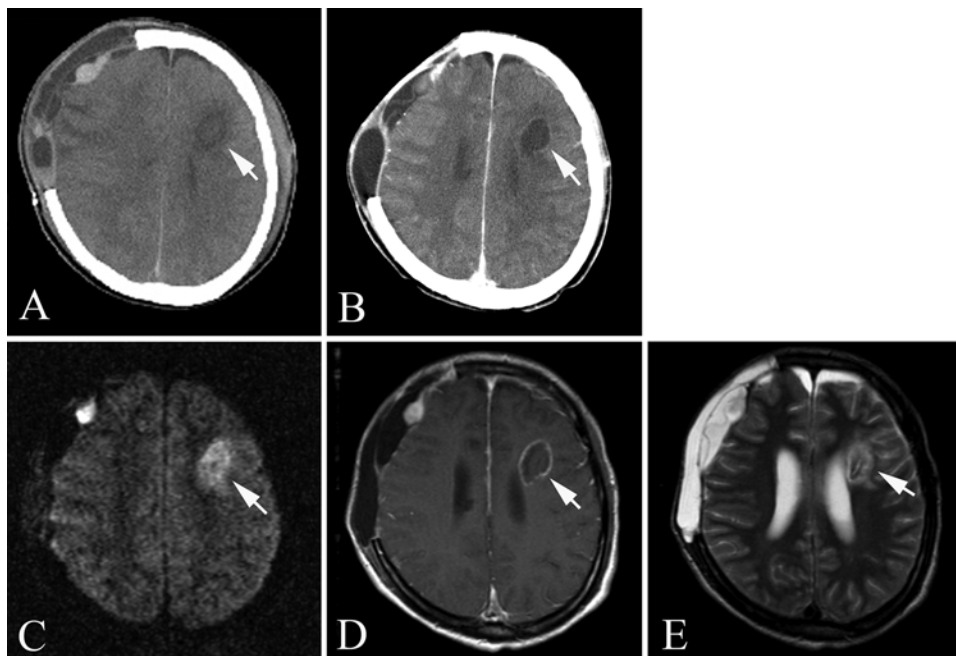
On Day 10, blood tests revealed a WBC count of 20,950 cells/mm³ and a blood sugar level of 145 mg/dl. Cerebrospinal fluid examination revealed a WBC count of 5730 cells/mm³ with 80% polymorphonuclear neutrophils and 20% lymphocytes, an elevated protein content (312 mg/dl), and a decreased glucose concentration (33 mg/dl). Another head CT scan was performed (on Day 10), and the radiology report indicated that the low-density area in the left frontal lobe at the previous location of the ICP transducer, near the frontal angle of the left lateral ventricle, was slightly more conspicuous than in the head CT scan from Day 5 (Fig. 2A).

This finding led to the suspicion of thermal brain injury caused by the overheated and melted ICP transducer during the MRI procedure. Contrast-enhanced CT scans on Day 27 and Gd-enhanced T1-weighted MRI scans on Day 28 revealed a ring-enhancing lesion (Fig. 2B and D). Diffusion-weighted and T2-weighted MRI on Day 28 revealed a well-circumscribed, ovoid, high-intensity lesion with a low-intensity center, approximately 26.5 mm in a diameter, in the left frontal lobe near the frontal angle of the left lateral ventricle, in the previous location of the ICP transducer (Fig. 2C and E). Furthermore, T2-weighted imaging revealed a high-intensity tract in a low-intensity center with a high-intensity small surrounding area, which did not have findings compatible with a brain abscess, such as a large high-intensity circumference indicating edema of the surrounding parenchyma (Fig. 2E). We diagnosed the lesion as a healing thermal brain injury, because the combination of a small high-intensity area surrounding the lesion and a low-intensity central area on T2-weighted MR images, which corresponded to the ring-enhancing lesion evident on Gd-enhanced T1-weighted scans, was compatible with coagulative necrosis.

flammation had decreased, and the CT scan obtained on Day 27 demonstrated a reduction in the low-density area compared with Day 10 (Fig. 2A and B). An MRI study of the head on Day 41 revealed a further reduction in the size of the lesion. Cranial osteoplasty was performed on Day 47 and there were no postoperative complications. The patient made an excellent cognitive recovery and was discharged to a rehabilitation unit on Day 59.

FIG. 2. **A:** Axial CT image obtained on Day 10 demonstrating that the low-density area in the left frontal lobe parenchyma (*white arrow*), in the previous location of the ICP transducer, is slightly more conspicuous than on Day 5. **B:** Contrast-enhanced CT image obtained on Day 27 demonstrating a reduction in the low-density area (*white arrow*) compared with Day 10. **C–E:** Axial MR images obtained on Day 28, including diffusion-weighted (C), Gd-enhanced T1-weighted (D), and T2-weighted (E) sequences. The diffusion-weighted and T2-weighted images demonstrate a high-intensity lesion with a low-intensity center approximately 26.5 mm in diameter (*white arrow*), which is a well-circumscribed ovoid mass deep in the white matter of the left frontal lobe near the frontal angle of the left lateral ventricle, in the previous location of the ICP transducer. The T2-weighted image also demonstrates a high-intensity tract inside a low-intensity center surrounded by a small high-intensity area. The high-intensity tract corresponds to the shape and location of the tip of the ICP transducer. The Gd-enhanced T1-weighted MR image reveals a ring-enhancing lesion (*white arrow*). The ring enhancement in the Gd-enhanced T1-weighted image (D) corresponds to the small area of high signal intensity surrounding the lesion in the T2-weighted image (E).

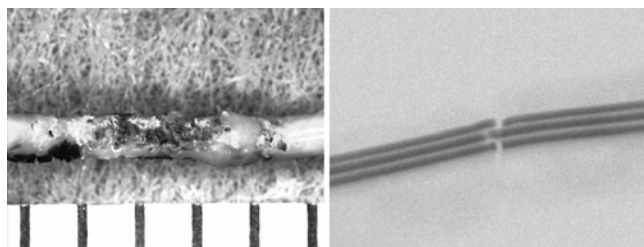
might form a closed loop if configured in parallel with the RF coil, or if it was touching the patient on another part of his body other than where it was inserted. They concluded that under these conditions, the RF energy of the MR scanner might induce an electrical current of sufficient magnitude to increase the temperature of the tip of the transducer, melt the nylon coating, and snap the

FIG. 3. Photographs of the Codman MicroSensor ICP transducer. **Left:** Enlargement of the photograph of the strain gauge transducer of the Codman MicroSensor used in the current case. (Each scale interval represents 1 mm.) Although the copper wire is not exposed, the transducer is melted and scorched at 7–12 mm from the tip. A black substance can be seen on the surface of the transducer tip. The appearance of this coating was consistent with charred blood. **Right:** Enlargement of a portion of a radiograph of the Codman MicroSensor ICP transducer removed from our patient demonstrating that the 3 copper conducting wires within the nylon coating were completely broken at 9 mm from the tip. Original magnification $\times 150$.

6th day of hospitalization (Day 6). The ICP transducer was melted and scorched when it was removed from the patient’s brain, and the wires had snapped. The patient developed a high fever and leukocytosis 3 days after the MRI study. Radiologists reported a low-density area in the left frontal lobe, at the previous location of the ICP transducer, on a head CT scan performed 4 days after the MRI study. No lesions had been seen at this location on either the head CT scan performed at the time of arrival or the MRI study performed on Day 6 (Fig. 1A–E). Contrast-enhanced CT performed on Day 27 and Gd-enhanced T1-weighted MR images obtained on Day 28 revealed a ring-enhancing lesion at the same location (Fig. 2B and D); T2-weighted MR images obtained on Day 28 revealed a central high-intensity tract inside a low-intensity center surrounded by a high-intensity small area, which corresponded to the shape and location of the tip of the ICP transducer. These findings were compatible with coagulative necrosis (Fig. 2E). We concluded that the ICP transducer had overheated and melted during the MRI procedure, causing thermal brain injury. Although definitive conclusions cannot be reached, it is distinctly possible that the meningitis was caused by exposure of the brain parenchyma to the nonsterile part of the transducer (titanium or copper inside the silicon- and nylon-coated tip). Alternatively, the meningitis may have been caused by insertion of a nonsterile transducer, or by contamination of the CSF during the right temporal lobectomy and decompressive craniectomy on Day 1. However, the timing of the onset of meningitis seems slightly too late for it to be related to the transducer insertion or surgery.

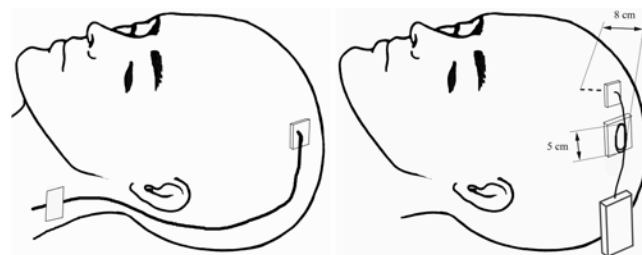
After insertion of the Codman MicroSensor transducer into the patient's brain parenchyma, we configured the transducer in a straight line (without any coiling of the nylon-coated sensor lead wires) and taped it to his neck (Fig. 4 left). We speculate that the major mechanism of the incident in the current case was the antenna effect, because there were no burns where the transducer was attached to the patient's skin, and only the tip of the transducer in his brain parenchyma was melted and scorched. Furthermore, resonance occurs most effectively when the length of one rotation of a receive coil is a multiple of λ , $\lambda/2$, or $\lambda/4$, where λ is the RF wavelength of the scanner. The total length of the Codman MicroSensor ICP transducer is 1105 mm, which is close to $\lambda/4$ (1180 mm) for a 1.5-T, 63.5-MHz MRI scanner.

Fig. 4. **Left:** The configuration of the transducer in the current case. After insertion of the Codman MicroSensor into the patient's brain parenchyma, we configured the transducer in a straight line, without coils, and taped it to his neck. **Right:** Drawing of the configuration for MRI based on the manufacturer's recommendations and guidelines. (See *Appendix* for specific details.)

been one of the causes of overheating of the transducer tip in the current case. The SAR limit recommended by the FDA and the International Electrotechnical Commission has recently been deregulated. Therefore, the whole-body-averaged SAR limit of 1.0 W/kg in the manufacturer's guidelines for the Codman MicroSensor seems to be slightly too strict. If this SAR limit is adhered to, it will be necessary to consider alternative scan sequences, which decrease the whole-body-averaged SAR, to maintain the quality of MR images.

oped a precautionary tag in cooperation with them, which clearly illustrates the correct configuration of the transducer and the important parameters for safe MR scanning. The manufacturer attached the tag to all display units in hospitals using this product in Japan immediately after it was produced.
